Floating Nanoammeter

Adam West

March 29, 2017

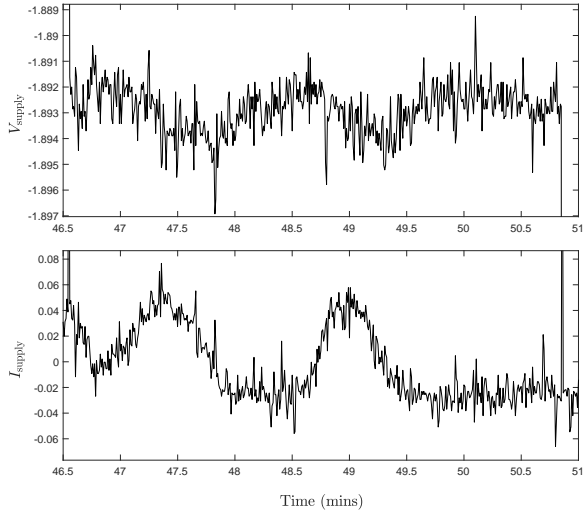
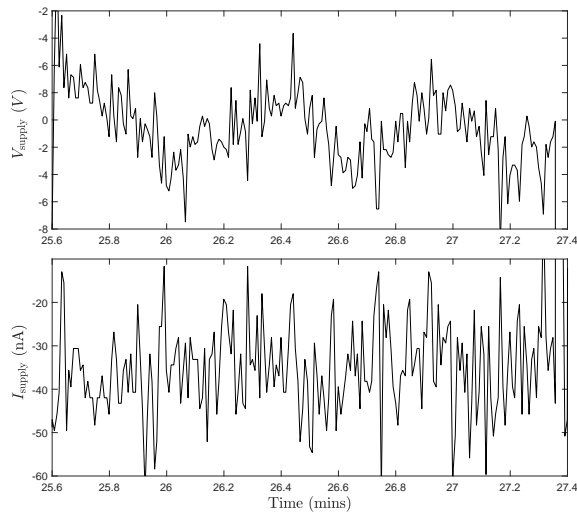
Next, the ammeter was included, between the supply and the bullet. Some weird behaviour was seen. First, it was noted that there were some oscillations in both the voltage and current reported by the HV supply. This is illustrated in Fig. 5, which shows some data taken at a nominally constant voltage of -1.9 kV . The oscillations are quite slow, with a period of ~ 1 minute. We also note that the voltage and current oscillations seem to be approximately $\pi/2$ out of phase, which one would expect for something charging and discharging¹. The voltage oscillations are quite small — around 1 V out of 2 kV, i.e. $\sim 0.1\%$, however the current oscillations are quite significant, at around 40 nA amplitude. There is no sign of such oscillations in the nanoammeter readout.

For now, I don’t have a model for what causes these oscillations. It is notable, however, that they also occur when there is zero voltage applied, as shown in Fig. 6 If we look back at the data without the ammeter connected, we do not see these kinds of oscillations, which is quite peculiar. This would suggest something happened to make these oscillations start happening, or that they are caused just by the ammeter circuit being connected, independent

Figure 5: Oscillations in the voltage and current reported by the power supply with the nanoammeter connected at high voltage. Again the circuit is terminated by a potted ‘bullet’.

Figure 6: Oscillations in the voltage and current reported by the supply with a nominally zero voltage.

of any high voltage effect. It would perhaps be interesting to go back, remove the ammeter, and verify that the oscillations do indeed go away.

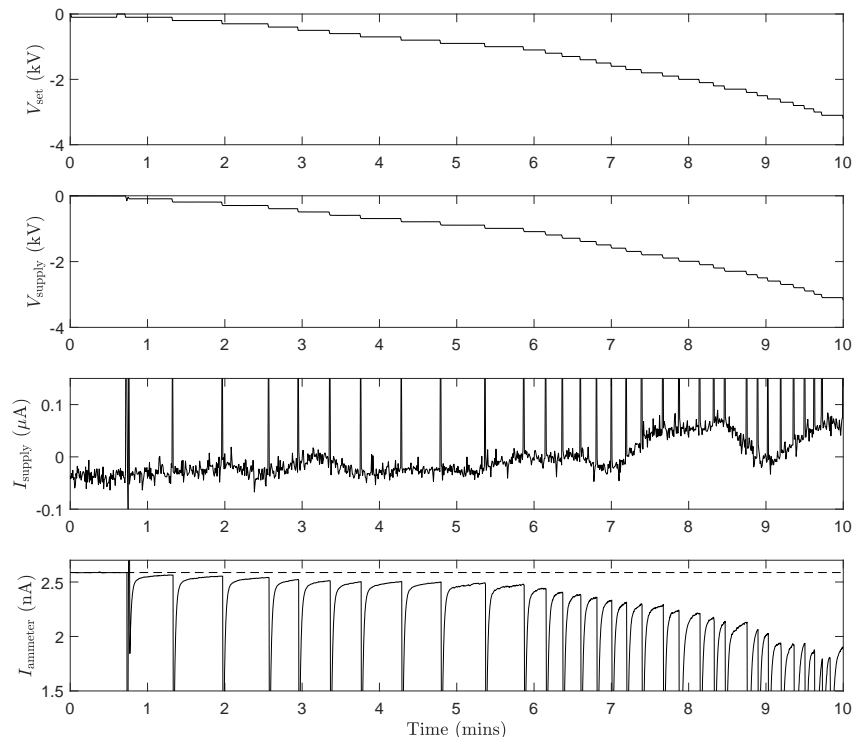
If we look at the current reported by the ammeter as the voltage is increased, we see that there is a significant change, as shown in Fig. 7. Each time the voltage is changed, the current reported by the ammeter settles, over a

Figure 7: Change in the current reported by the nanoammeter as the voltage is increased.

fairly long time period (increasing with voltage), however it is still quite clear that the steady state value changes significantly as the voltage is changed. In Fig. 7, the voltage is increased to around 3 kV and the nanoammeter's reported current changes by around 50 pA. This is perhaps not that worrying in itself, since 50 pA is small, however, at these low voltages we would really not expect such a change, particularly as we were able to demonstrate greater stability before the ammeter was potted up — between 0 and 5 kV we observed a change of ≈ 10 pA.

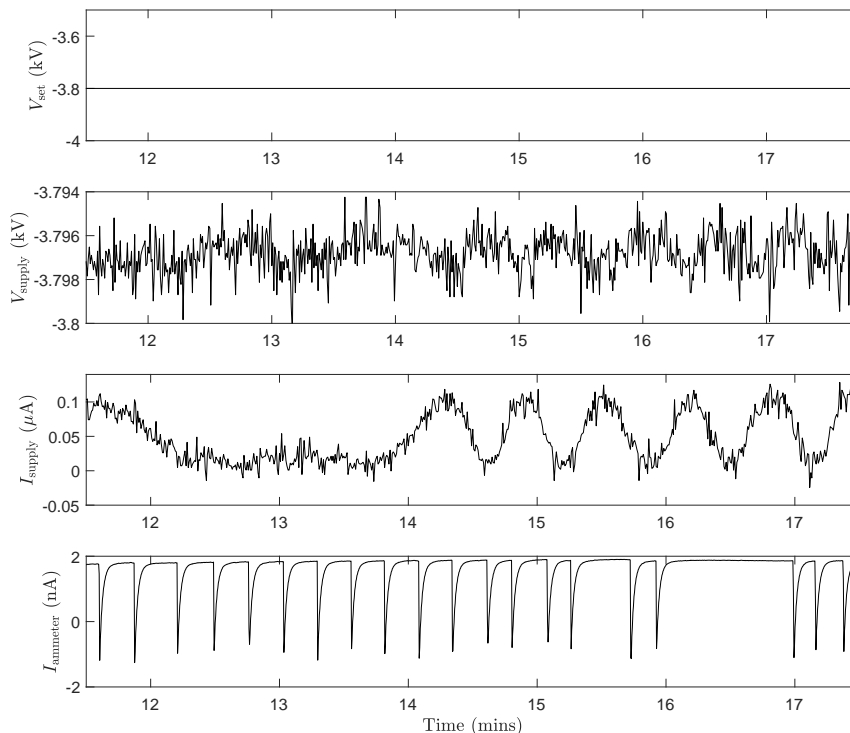
A second unusual effect that we observed was an instability in the nanoammeter reading. At higher voltages, the readout would spike in a quite regular manner. This is illustrated in Fig. 8. The nominal voltage was set at

Figure 8: Current spikes reported by the ammeter with a constant voltage applied (-3.8 kV).

-3.8 kV and unchanged. Note that the HV supply reports it to be accurate to this value within a few volts, and that both the voltage and current it reports show the aforementioned oscillatory behaviour again. However the most striking behaviour is from the ammeter, which shows regular spikes in the reported current of around 3 nA in size, occurring every 10 s or so. We saw that this spiking at constant voltage began to occur when the voltage was raised to around 3 kV, and that the frequency of such spikes increased as the voltage increased.

Again, I am not sure what is causing this behaviour, however I believe that the current is real, since it is clearly voltage dependent. If it is indeed real, the question is of course where is it. It seems reasonable to assume that it is coming from the nanoammeter circuit since it represents a big array of emission points. We cannot see the same spikes in the current reported by the supply, however we would not expect to since the magnitude of the spikes is less than the noise. If we change the polarity of the applied voltage we see very similar behaviour, but with the sign of the current spikes reversed.

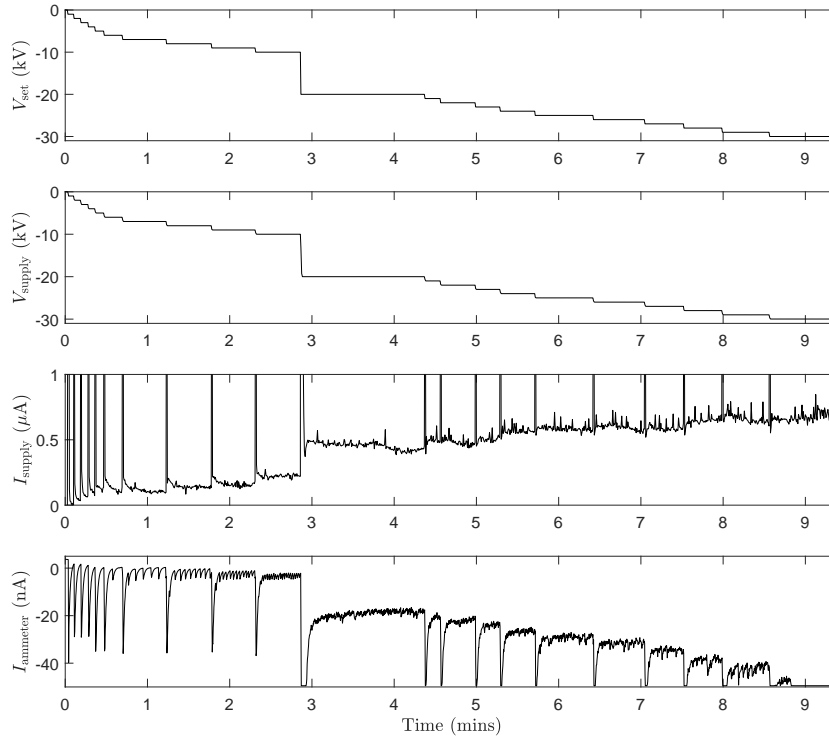
The data in Fig. 9 show the behaviour as the voltage is increased further. The aim was to increase in steps of 1 kV, unfortunately the voltage was mistakenly stepped from 10 kV to 20 kV at around the 3 minute mark. From 0

Figure 9: Data taken whilst increasing the voltage up to its maximum value of 30 kV. Note the large rise in the current reported by the nanoammeter.

to 10 kV one can clearly see the spikes in the nanoammeter readout, inbetween voltage steps. You can also see that their frequency increases with voltage. Unfortunately, as the voltage is increased further, the nanoammeter offset continues to increase, quite significantly. Indeed, at the maximum voltage of 30 kV, the current reported by the ammeter reaches its maximum value of 50 nA². Additionally, the signal becomes much noisier, with fluctuations of several nA.

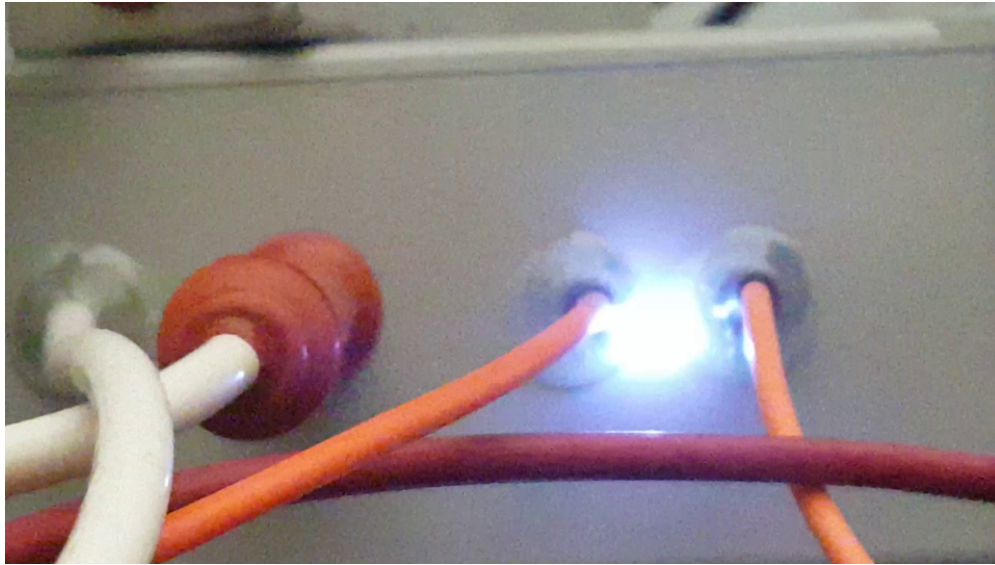
Figure 10: Spark observed between the two optical fibers connecting to the ammeter.

After observing the behaviour described above, I returned to do some further testing, to try and discern whether the observed leakage current was just in the ammeter box or elsewhere as well. While repeating tests in the previous configuration, I saw sparking when the voltage reached around 28 kV. Fig. 10 is perhaps the best picture of it. It is occurring between the two optical fibers, i.e. the fiber supplying power to the ammeter circuit, and the fiber carrying the data out of the circuit. This behaviour was very repeatable, as shown in the following montage: [link](#)

As the voltage neared the level where these sparks happen, I could hear what sounds like microdischarges occurring - it was hard to locate where.

The distance between the two fibers is approximately 1.5 cm. The dielectric strength of air is around 30 kV/cm. This suggests that the voltage difference between the fibers must have been close to the total applied voltage in order for this breakdown to occur, i.e. one fiber was at approximately ground, and one was at approximately 30 kV.

In future we should improve the setup by having a larger section of optical fiber potted inside the box and grounding the optical fibers to the box as they pass through — for this we can try using conductive epoxy.

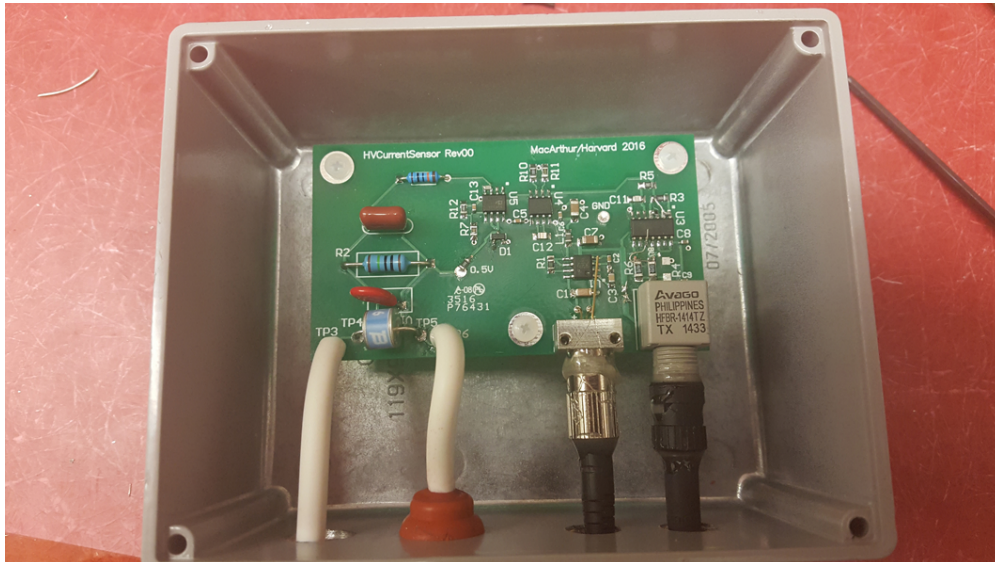
The inside of the ammeter box is shown in Fig. 11. On the right we see the two fibers. The left-hand one is used to provide the light to the photovoltaic converter which powers the device. It has a metal connector/ferrule.

Figure 11: The inside of the nanoammeter box before being potted.

The right-hand fiber is used to extract the signal from the device. It has a plastic connector. The fibers are glued in place with 5 minute epoxy in order to prevent any potting compound entering the connector. On the left we see the connections for the high voltage. The fibers are also epoxied in place at the box, to prevent leakage of potting compound.

Whilst the fibers are nominally insulating, they will have a non-infinite resistance. I tried to measure this resistance using an electrometer but was not able to — even without the leads connected to anything, the electrometer read around $20 \text{ G}\Omega$ initially, gradually rising up to its limit of $200 \text{ G}\Omega$. This may be worth looking into further.

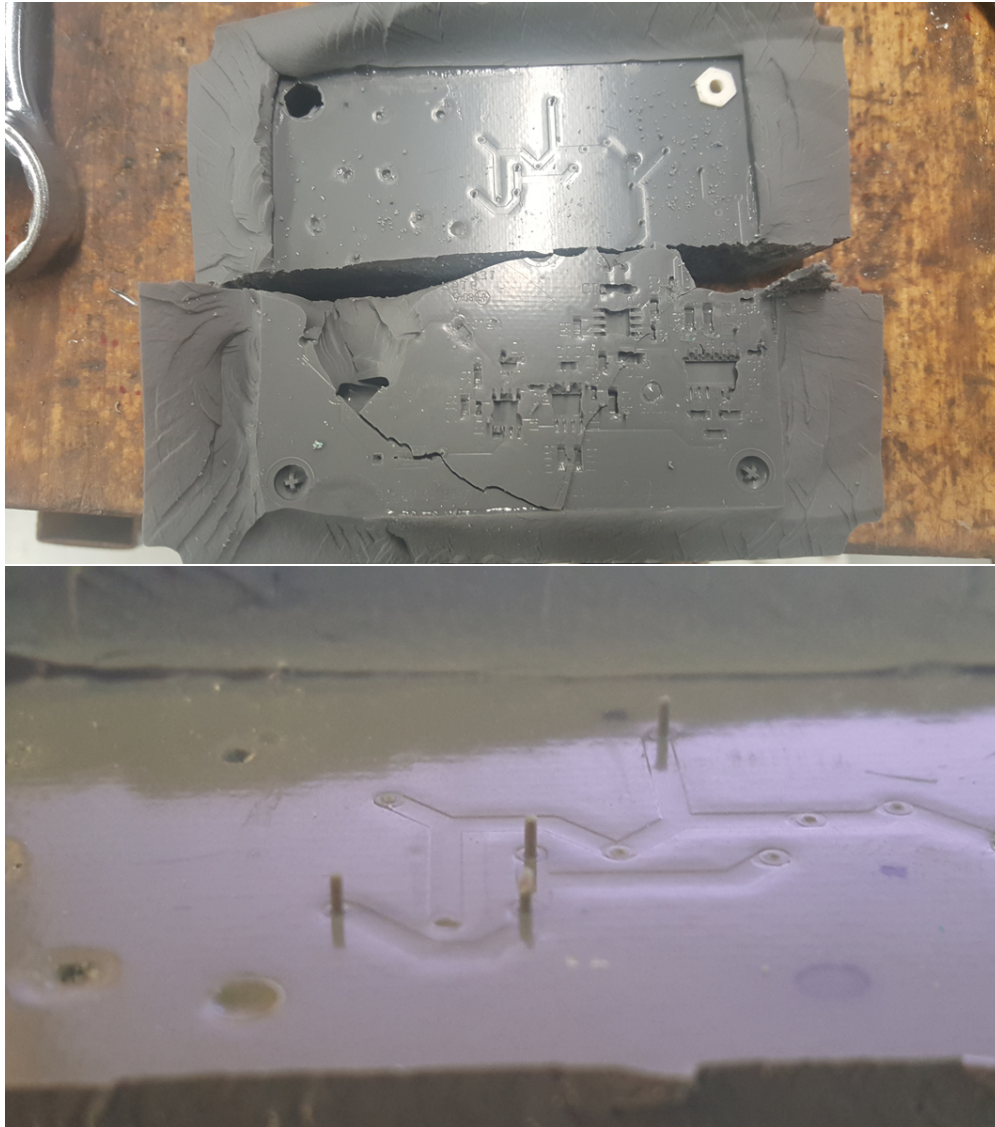
I was able to extract the circuitboard from the potted box; cutting through the box and potting compound to close to the circuitboard allowed the silicone to then be torn off. Fig. 12 shows a couple of pieces removed. We see that the details of the circuitboard are clearly impressed on the silicone, suggesting that the efficiency of filling and

Figure 12: Pieces of silicone that were used to pot the ammeter.

conforming to the surface was high. In particular, the bottom picture shows some very small features which were filled. In addition, whilst removing the silicone there was no evidence of air gaps or bubbles at all.

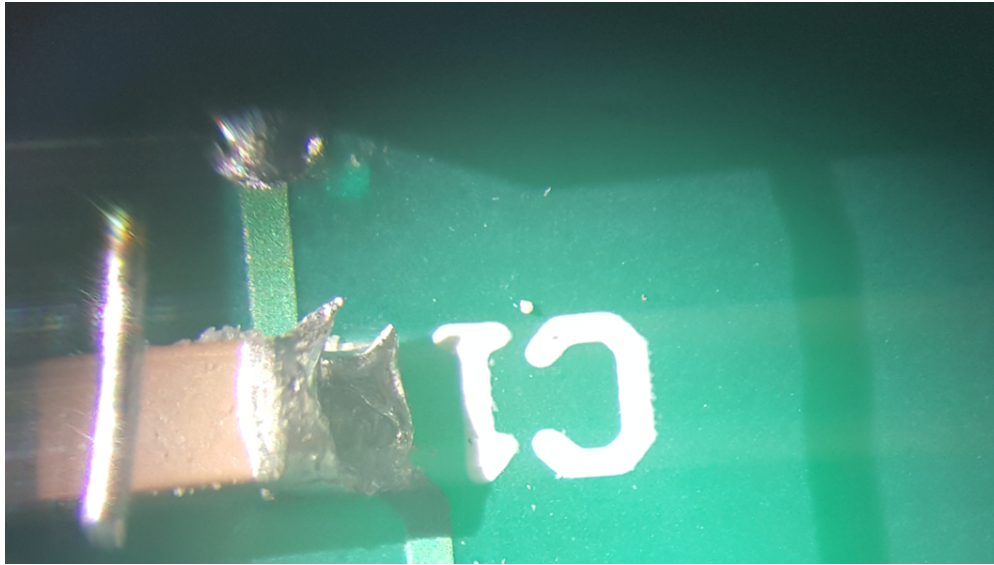
After extracting the circuitboard, I gave it to Jim to perform a post-mortem. He found that there was damage to an op-amp through a diode, and he believes that the source of the damage is a discharge emanating from the photovoltaic converter that passed to a nearby capacitor. A picture of the capacitor, taken through a microscope, is shown in Fig. 13. We see that the solder joint on one side of the capacitor seems to be damaged — it looks like there is a small crater taken out of the solder on one side. There is no evidence of damage from any nearby components. To try and prevent this in future we could try moving the photovoltaic converter further away from the rest of the board components. Also, the case of the photodiode (and hence presumably the case of the photovoltaic unit as a whole) is currently not connected to anything, so it may be better if we simply connect it to either the positive or negative terminal of the photodiode.

Figure 13: Picture of a surface mount capacitor which looks as if it may have been damaged by an electrostatic discharge.

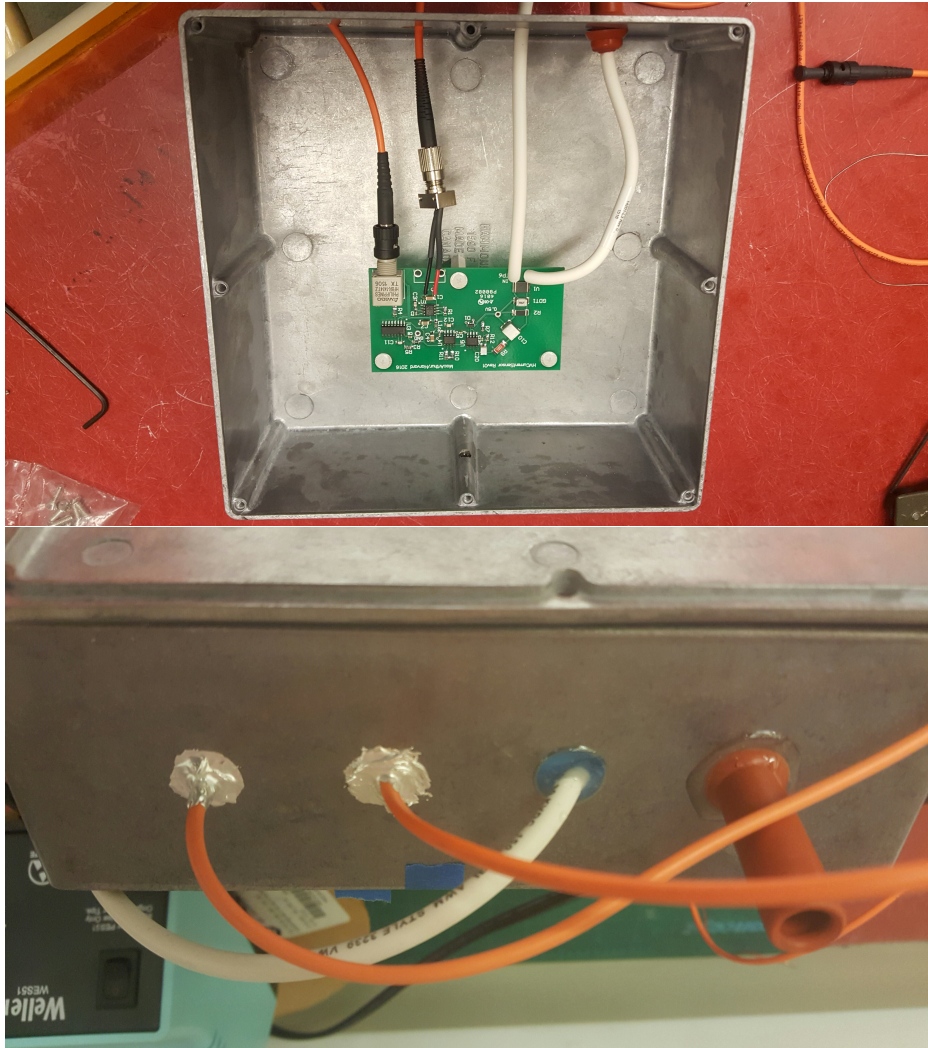
Figure 14: A floating ammeter was potted with silicone inside a new, larger box. Silver epoxy was used to seal around the optical fibers so that they were better grounded.

For the next iteration of testing we made a few changes. To avoid the problem of arcing between the optical fibers we used silver solder to seal around the fibers where they passed through the metal box. This should explicitly ground them and prevent high voltage passing along their surfaces to outside the box where they can arc. We also explicitly tied the case of the photovoltaic converter to the positive lead of the photodiode to prevent the case floating to an unspecified voltage, which may have encouraged discharging to occur inside the box. Additionally, the box in which the ammeter was potted was made significantly bigger so that the high voltage wires and the fiber optic cables were inside the silicone for a greater distance before exiting the box. Fig. 14 shows pictures of this new box.

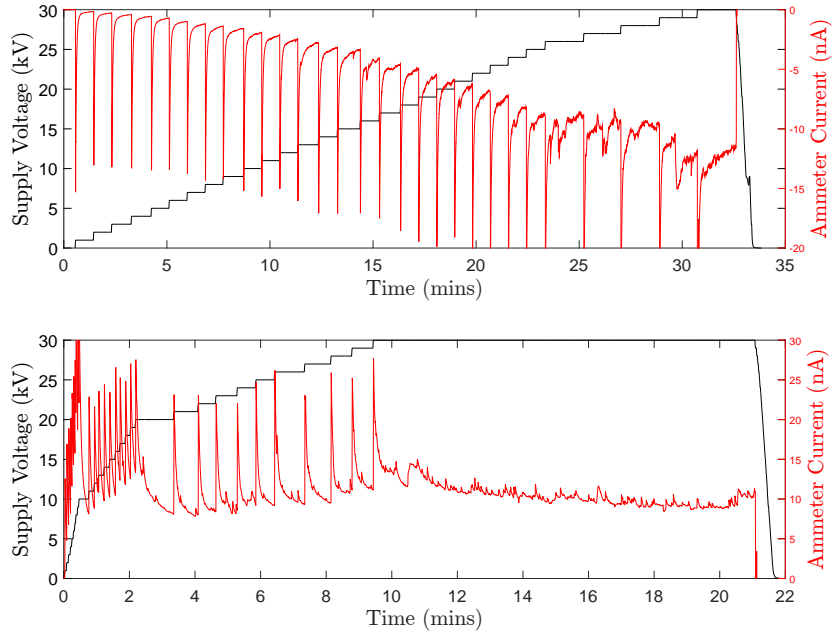
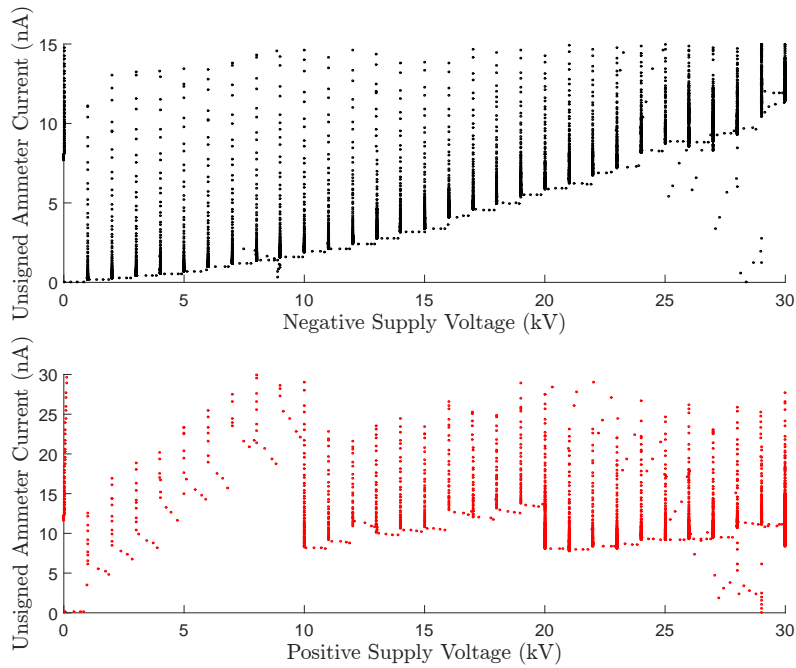
After these changes, we tested the system again to see if the problem of arcing had been mitigated, and if the leakage current which we had previously observed had been reduced. The resulting data are shown in Fig. 15.

Firstly, we did not see or hear any evidence of arcing happening between the optical fibers — it seems that this problem was solved. However, the current levels reported by the floating ammeter were still quite high; we see that the current has increased by 1 nA when the voltage is at -6 kV, 5 nA by -20 kV, and reaches a 10 nA increase for -30 kV. Similar behaviour is observed with a positive applied voltage. We also see that there are large (greater than 10 nA) spikes with every 1 kV step in voltage, and at higher voltages the current becomes quite unstable, fluctuating by several nA for a nominally fixed voltage.

If we plot the reported current vs the applied voltage, as shown in Fig. 16, we can see the general correlation a little more clearly. The large spread in current values is due to the spikes associated with stepping the voltage.

Figure 15: Current reported by the floating nanoammeter and voltage reported by the power supply as a function of time. Ammeter is in silicone in a large box. The top (bottom) plot shows data with a negative (positive) applied voltage.

Figure 16: Current reported by the floating nanoammeter vs voltage reported by the power supply. Ammeter is in silicone in a large box.

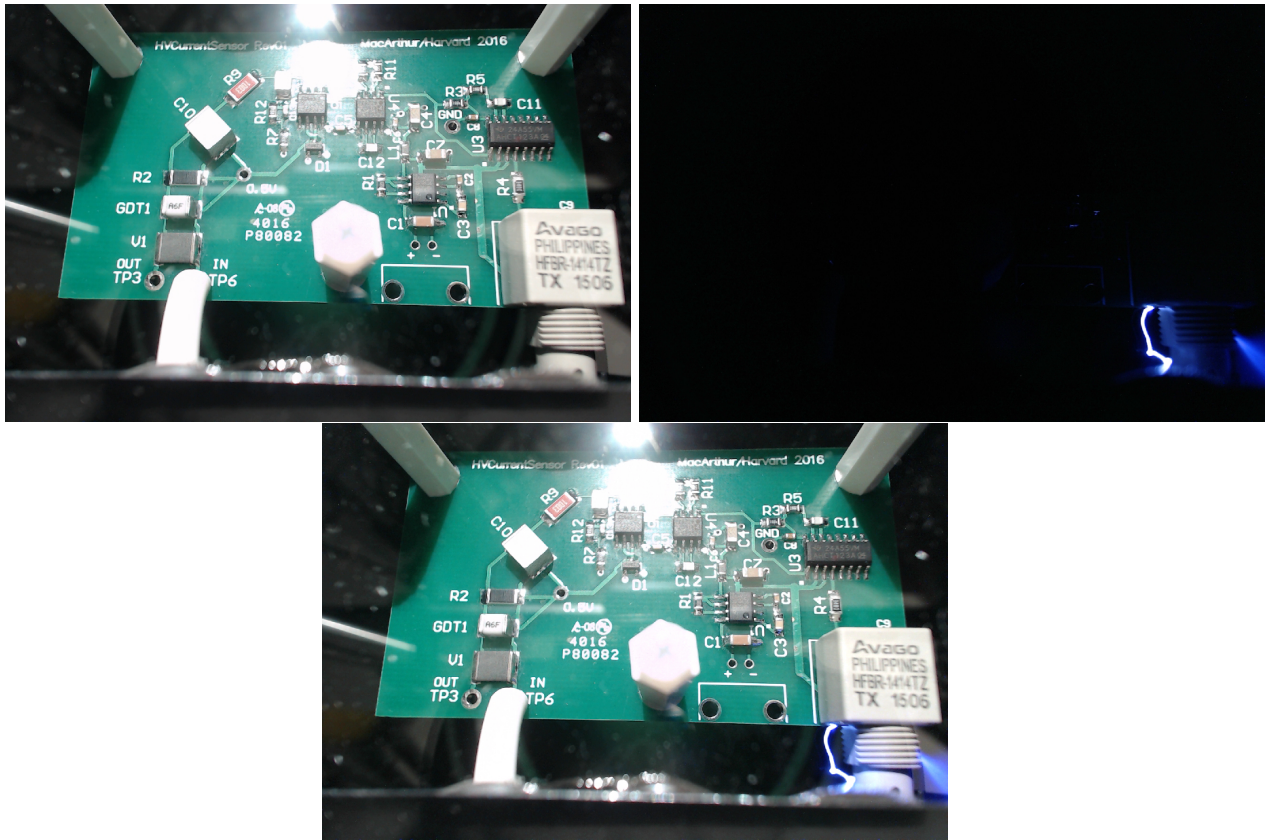
Initially, no signs of corona etc. were observed, even when charging up the circuit to 30 kV. While perhaps reassuring, this was not useful. In order to try and induce corona we moved the circuit board closer to the lid of the pail by shortening the standoffs which attach it to the lid. This was done incrementally, first shortening them to 3 in, then 2 in and finally 1 in. It was not until the standoffs were only 1 in long that we observed any corona. The corona/arc is shown in Fig. 22. The top left image shows the ammeter through the window in the pail. The top

Figure 22: Pictures of the ammeter circuit showing the position of corona/arc events.

right image is a combination of two photos which contained an arc (to the left) and some corona (to the right). The bottom image is a combination of the upper images, showing the position of the discharges. The corona seemed to start occurring when the voltage reached 25 kV, and arcing occurred at around 28 kV. There was some observed hysteresis — the corona was maintained until the voltage was reduced to 20 kV. Looking at the images we see that the discharges seem to be concentrated around the optical pulse generator which is used to transmit the current reading through an optical fiber.

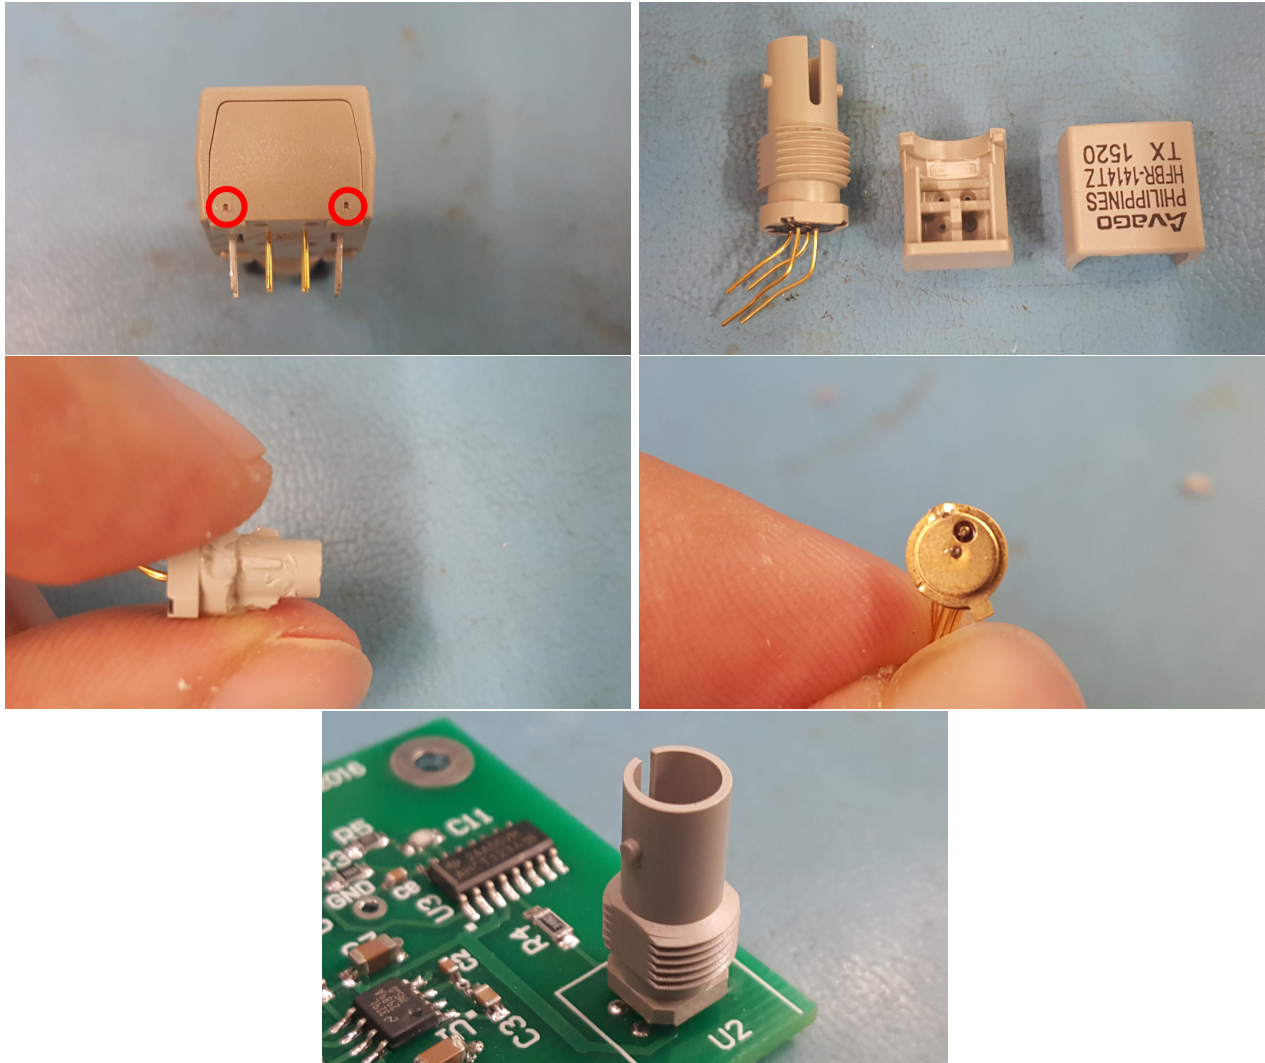
After observing this I closely examined the optical pulse generator to try and identify the source of the problem. The images below show what I found while dismantling this component. The first image (starting from top left) shows the component from the rear side, giving the clearest view of what we suspect the problem to be: the red circles highlight very small holes in the plastic housing (present on both the front and back). Set slightly back from the holes, there is metal. Upon disassembly it seemed that this metal performed no function, other than mechanical. As far as I could tell, there seemed to be a small piece of metal encapsulated in the housing to provide rigidity. At the holes highlighted there seemed to be a sharp edge/corner of that metal. The component has eight pins — the central four (gold coloured) connect to the LED inside (see image 2), and the outer four are there solely

Figure 23: Pictures of the optical pulse generator being dismantled. See main text for description.

for mechanical purposes and seem to connect to the aforementioned encapsulated metal. Image 2 shows that it is thankfully relatively easy to remove part of the casing, separating the LED and ST fiber connector from the rest of the package. Image 3 is after having cut away the ST connector part of the package — the LED is encapsulated in plastic still. Image 4 shows the rest of the plastic having been cut away, leaving just the LED itself. Image 5 shows the LED and ST connector (left-hand piece in image 2) soldered onto the circuit board in place of the original package. Note the now-unoccupied pins around the component which were previous used for mechanical support (the component is still plenty rigid).

Hopefully this will have reduced or solved the problem of residual leakage current which we have been observing. We can either test again in air to see if there is any corona, or test in oil to measure the leakage current. One slight problem is that we are running out of the photovoltaic converters. Of the 4 originally purchased, one is on the circuitboard currently in oil. One is in a silicone-potted circuit board, one is on a previous iteration of the circuit, but not usable since it had the grounding pin cut off. One had a leg break when being handled (presumed faulty). Alternatively, we have ‘panel mount’ style photovoltaic converters, shown in Fig. 24. It is somewhat bulkier and might not fit on the board as nicely. It would also require modification due to the mis-sizing of the FC-connector.
