Floating Nanoammeter

Adam West

March 29, 2017

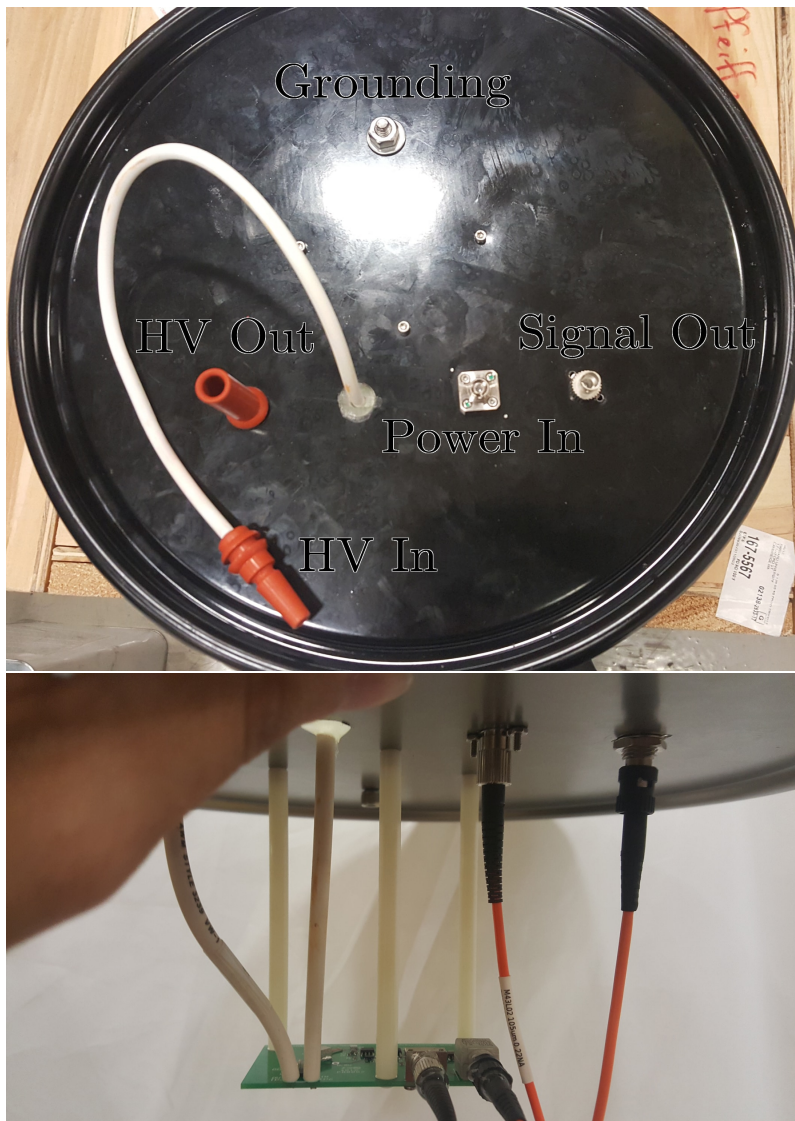
After observing that the problem of leakage current had not gone away, we decided to try insulating the floating ammeter with transformer oil instead. The oil that we are using is Shell Diala S4 ZX-I and was purchased from here. The dielectric strength of the oil is very comparable to the silicone, but there should be no ambiguity as to whether it is conforming to the shape of the PCB etc. since it is liquid. It also makes it easier to remove the PCB after testing, make changes, and retest it. Images of the bucket which was modified to house the ammeter are shown in Fig. 17. The high voltage connections to the ammeter are made in a very similar manner — silicone cables are epoxied in place on the lid. The optical fiber connections for the power and signal are made via bulkhead connectors which are screwed into the lid. A separate connection is provided for explicit grounding of the bucket. The fiber bulkhead connectors have good connection with the ground connection. The PCB is suspended from the lid by 4 inch long nylon standoffs which are screwed into the lid. The fiber connection on the PCB were again sealed with 5-minute epoxy however we note that it is likely that during assembly/modification of this setup that oil got into the fiber connections on the lid, and did not seem to prevent successful operation.

Figure 17: Nanoammeter mounted inside a bucket which will contain transformer oil. The top image shows the connections in/out. The bottom image shows the PCB mounted to the underside of the lid.

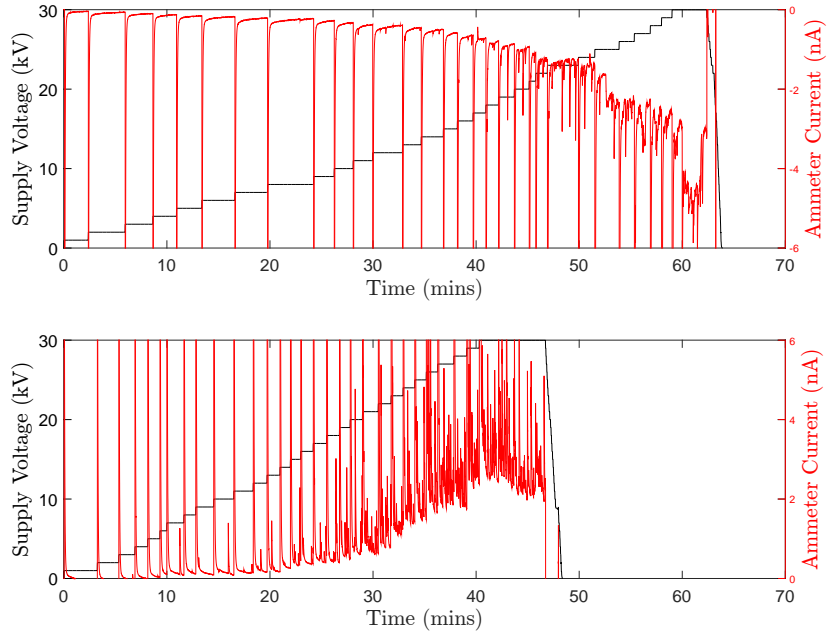
We suspected that there may have been some surface effects occurring which were producing the observed leakage currents, in particular along the standoffs we were using. The standoffs were made of nylon (and were purchased from McMaster). While nylon is a good insulator, Teflon is supposedly better, both in terms of bulk resistivity and surface resistivity (although these properties are seemingly not very well known). To try and see if this was the problem, I bought some Teflon stock and machined some new standoffs (also 0.5 in longer). After replacing them, we performed the same tests as before — slowly ramping up the voltage and observing the measured current. The results were very similar, perhaps even slightly worse, i.e. several nA of current.

Figure 18: Current reported by the floating nanoammeter and voltage reported by the power supply as a function of time. Ammeter is in bucket of oil. The top (bottom) plot shows data with a negative (positive) applied voltage.

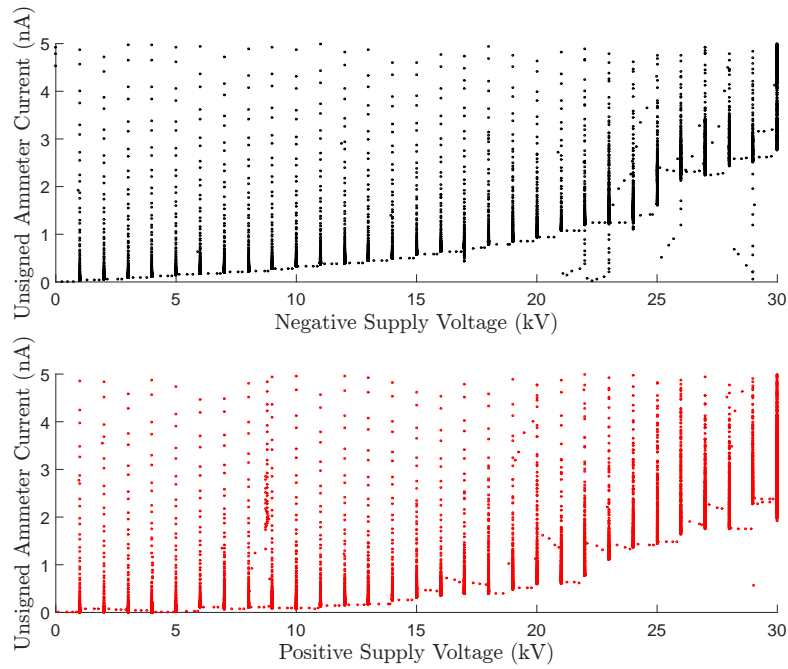
Figure 19: Current reported by the floating nanoammeter vs voltage reported by the power supply. Ammeter is in bucket of oil.

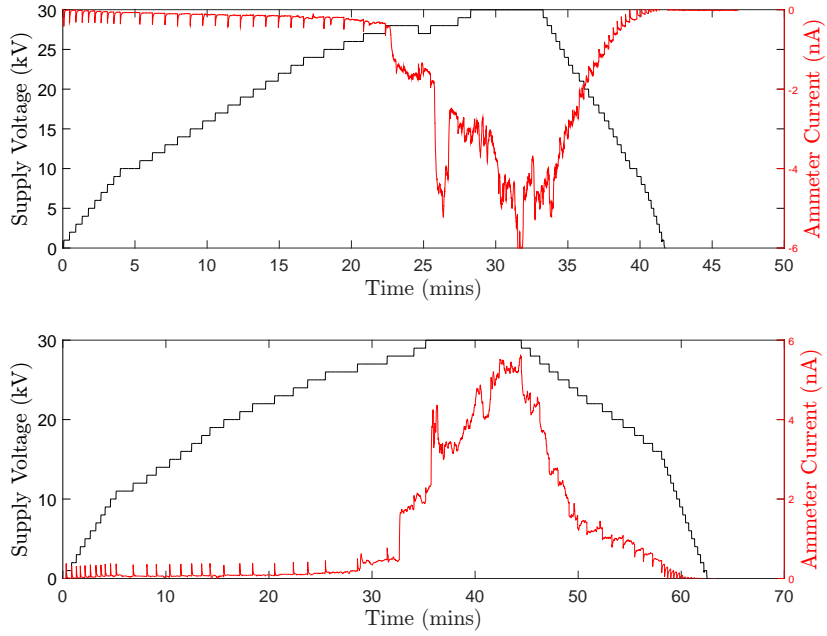
Figure 20: Current reported by the floating nanoammeter and voltage reported by the power supply as a function of time. Ammeter is in bucket of oil with output disconnected. The top (bottom) plot shows data with a negative (positive) applied voltage.

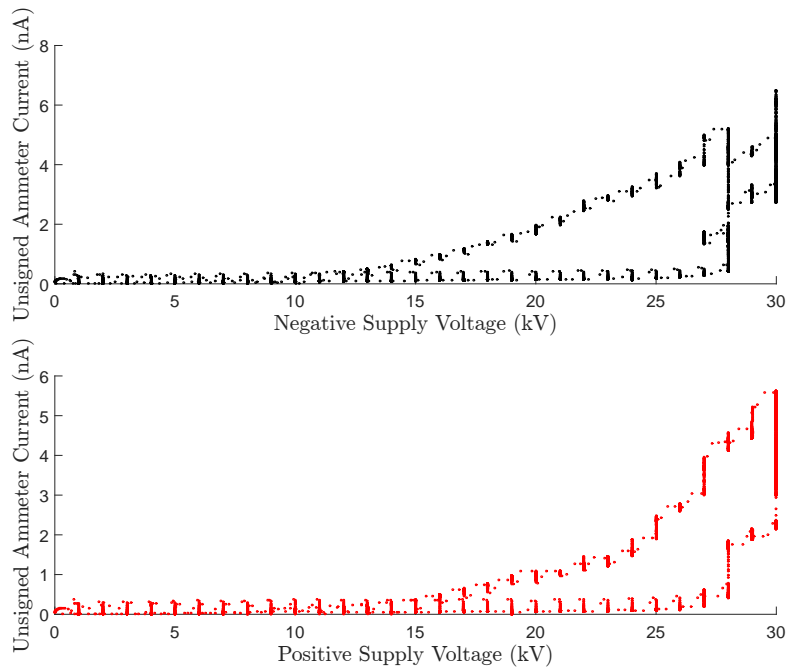
Figure 21: Current reported by the floating nanoammeter vs voltage reported by the power supply. Ammeter is in bucket of oil with output disconnected.
